ASBESTOS & LEAD-BASED PAINT SURVEY REPORT

I-210 Bridge Expansion
San Bernardino, California 92401

June 26, 2015
Partner Project No. 14-121800.1

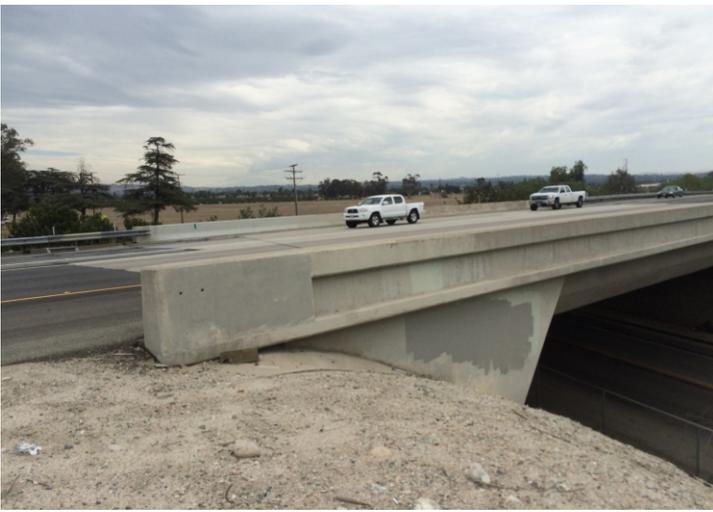
During the inspection no LBP was identified along the bridges and overpasses. Some of the samples contained detectable concentrations of lead below the threshold for LBP.

1. View of the painted overpass.

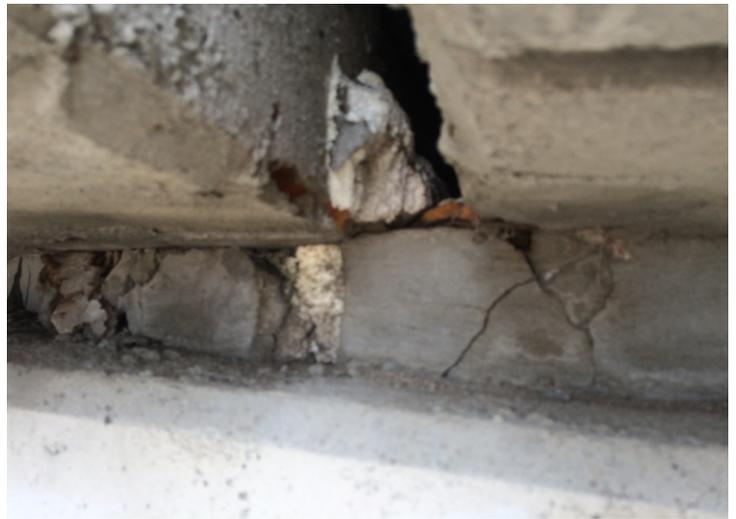
None of the materials sampled were reported to contain asbestos.

2. View of the bridge joint packing.

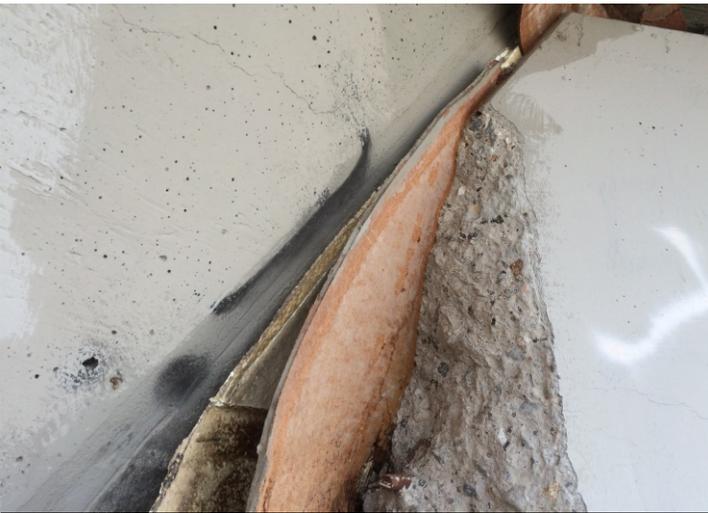
3. View of the bridge brown packing.

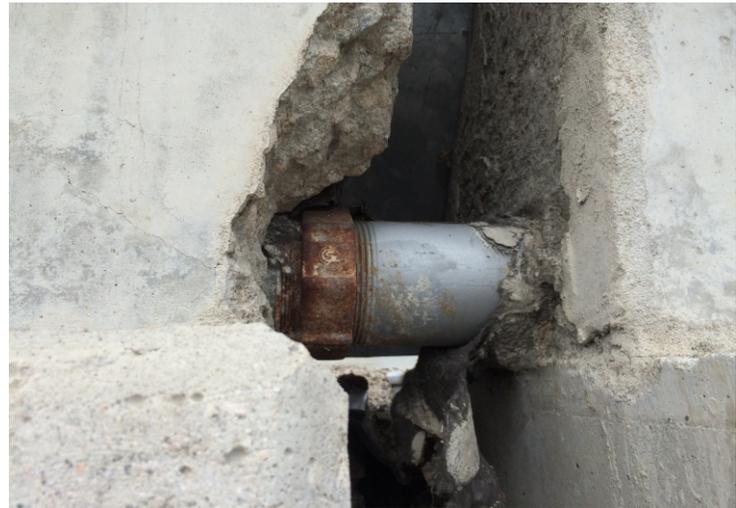
4. View of the bridge pipe insulation.

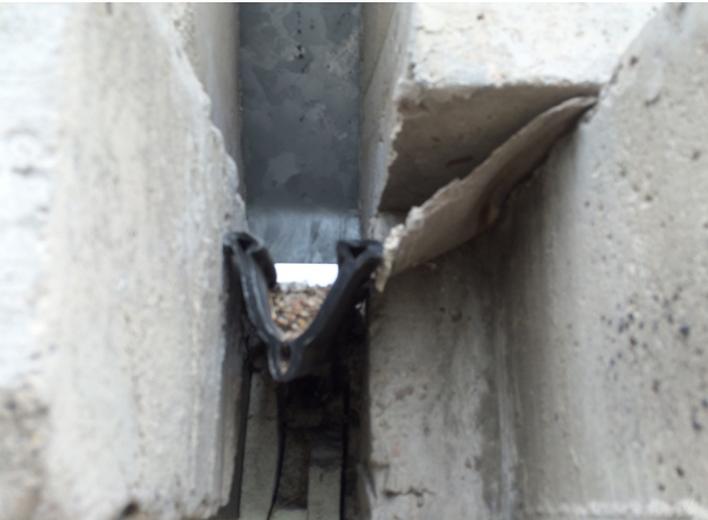
5. View of the bridge rubber seam joints.

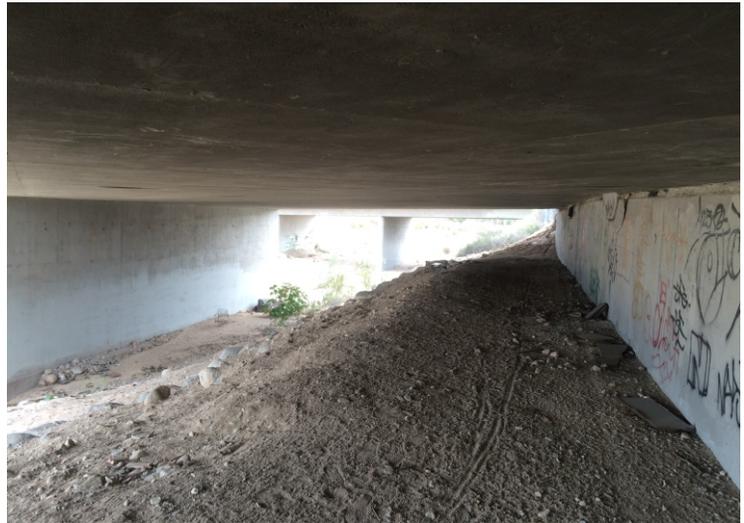
6. View of the bridge painted underpass.
