REDLANDS PASSENGER RAIL PROJECT
Slope Analysis and Photodocumentation
San Bernardino, San Bernardino County, California

July 2012

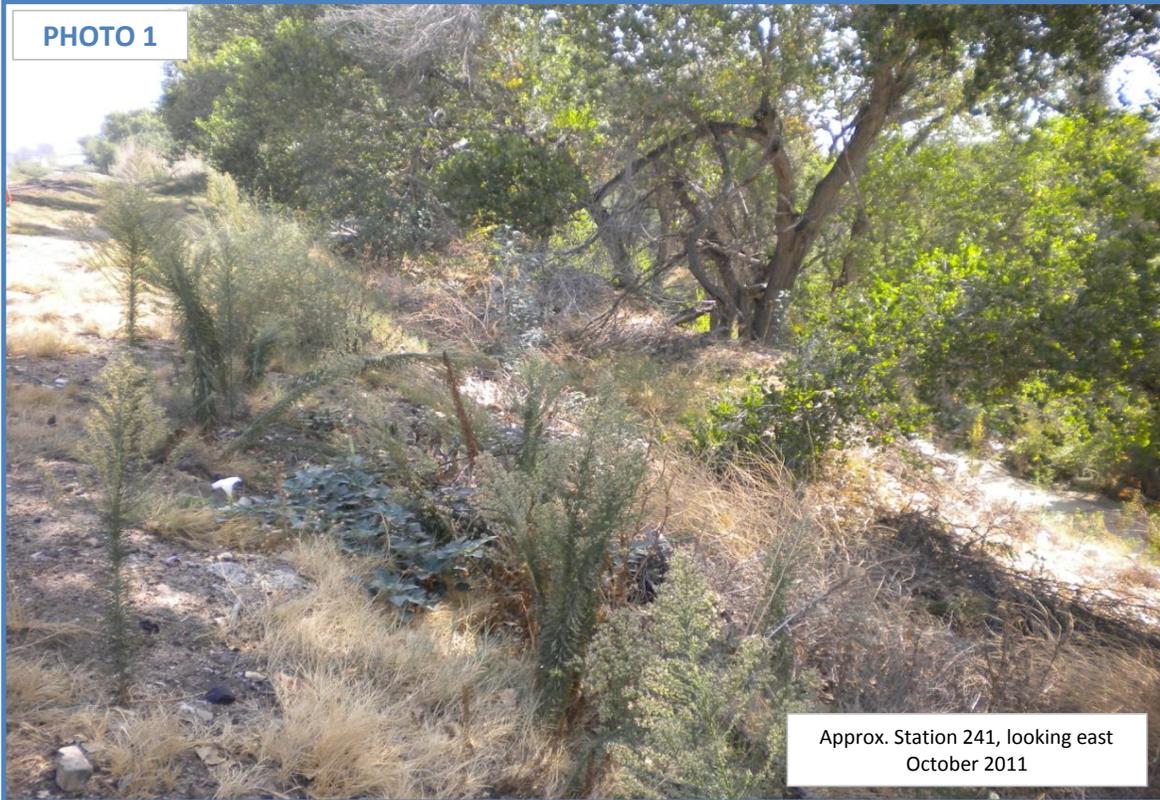
PHOTO 1

Approx. Station 241, looking east
October 2011

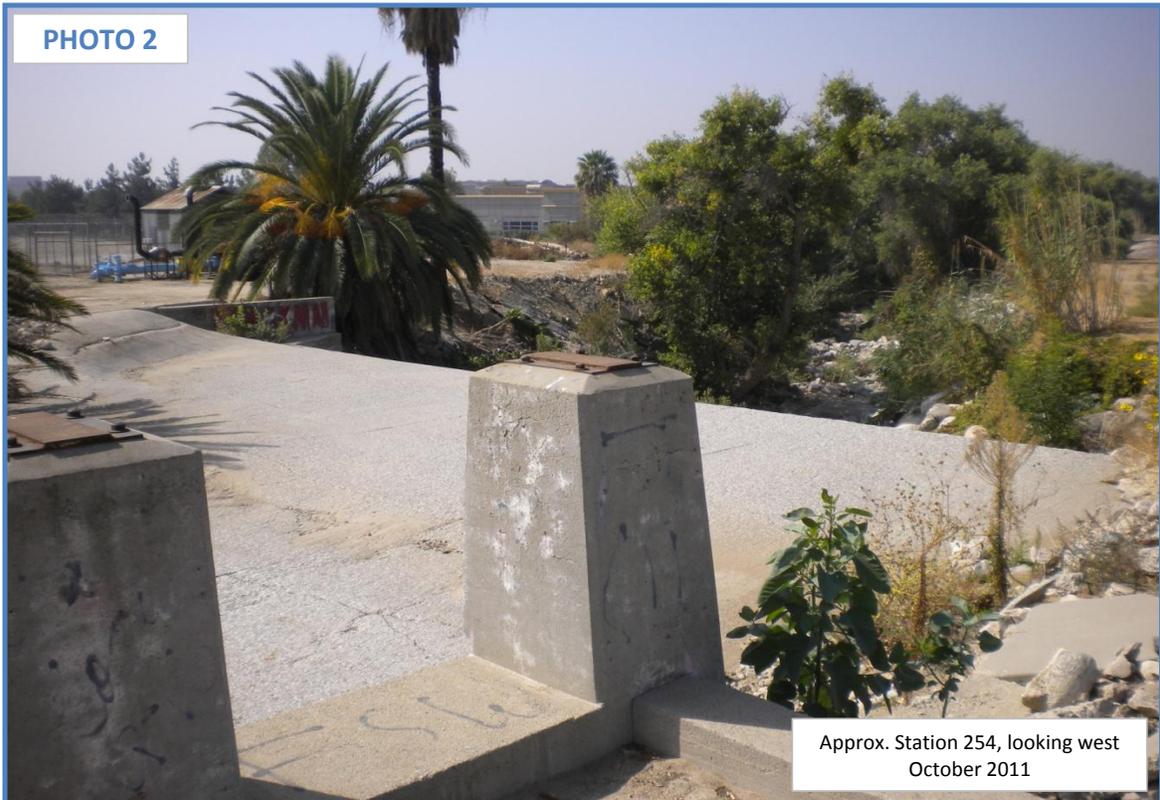
PHOTO 2

Approx. Station 254, looking west
October 2011

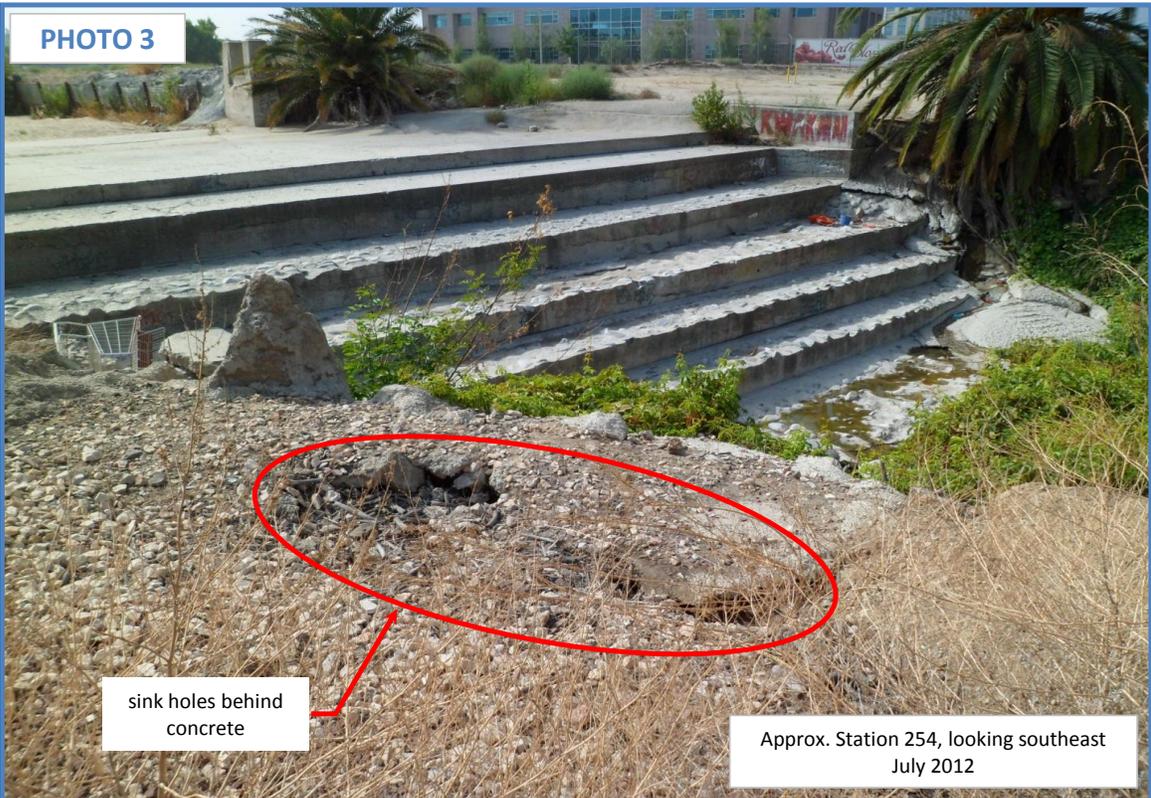
PHOTO 3

sink holes behind concrete

Approx. Station 254, looking southeast
July 2012

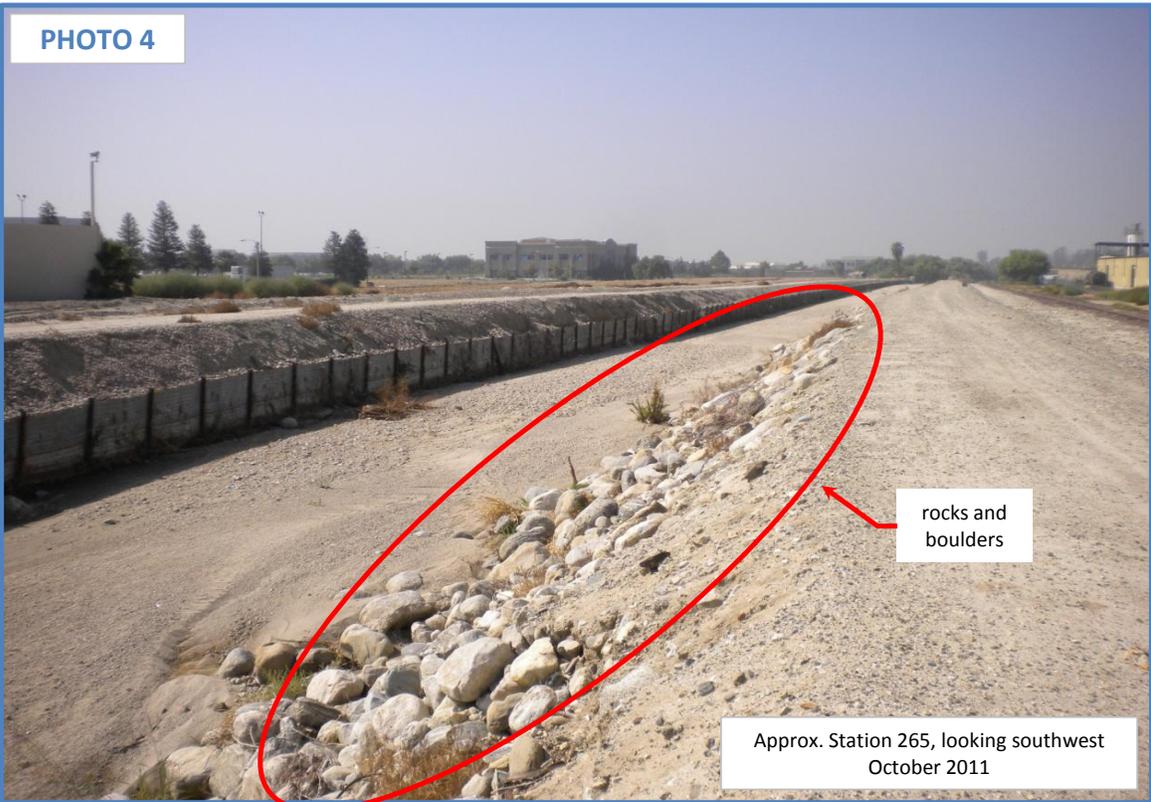
PHOTO 4

rocks and boulders

Approx. Station 265, looking southwest
October 2011

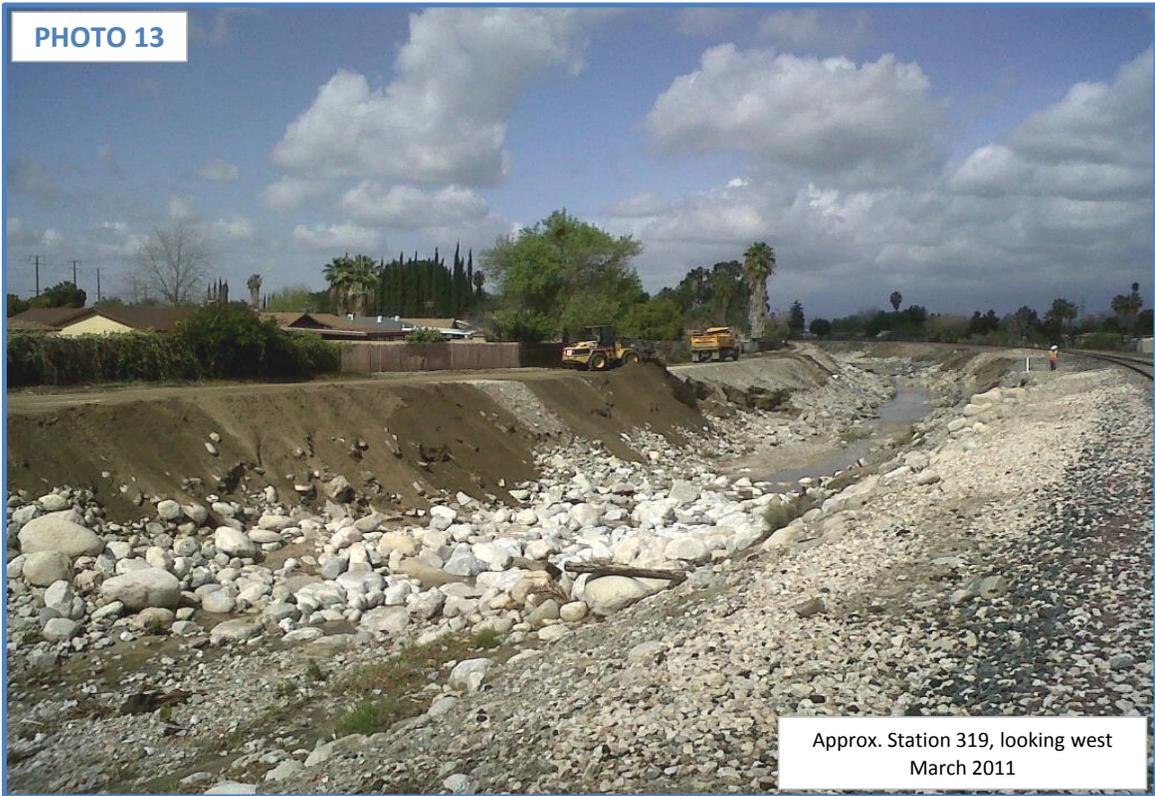
PHOTO 13

Approx. Station 319, looking west
March 2011

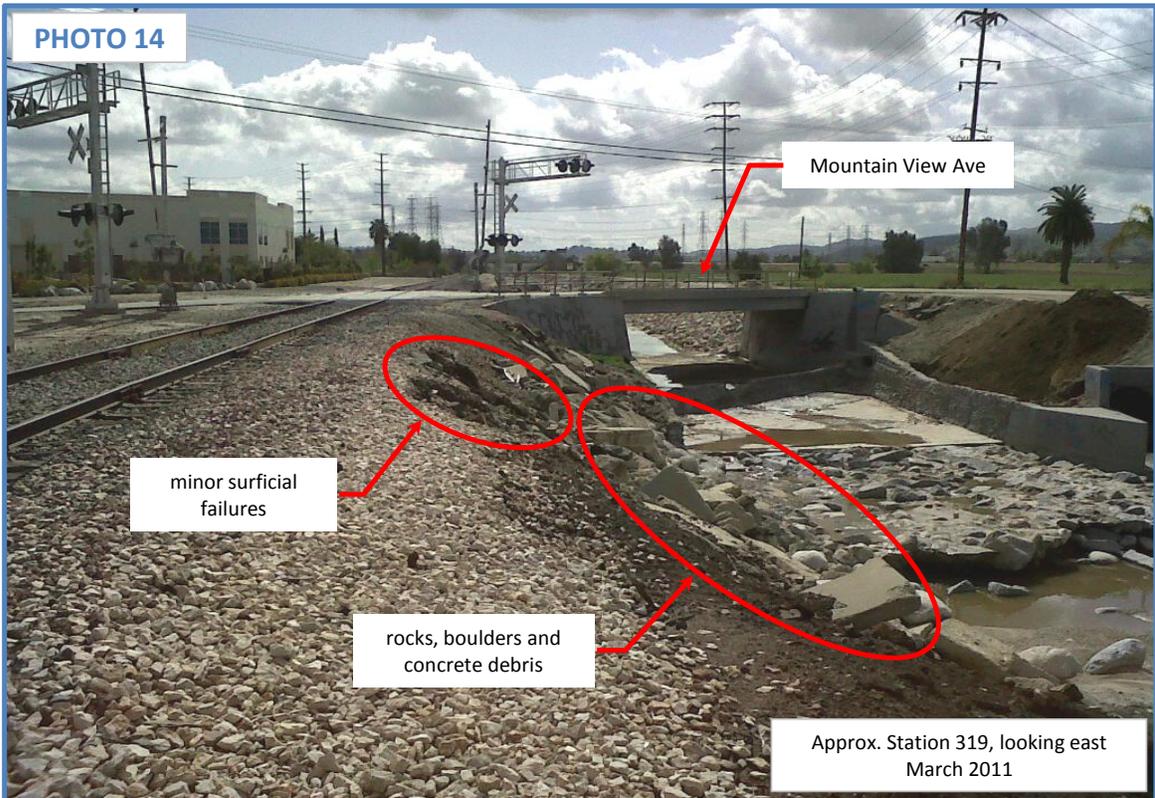
PHOTO 14

minor surficial
failures

rocks, boulders and
concrete debris

Approx. Station 319, looking east
March 2011

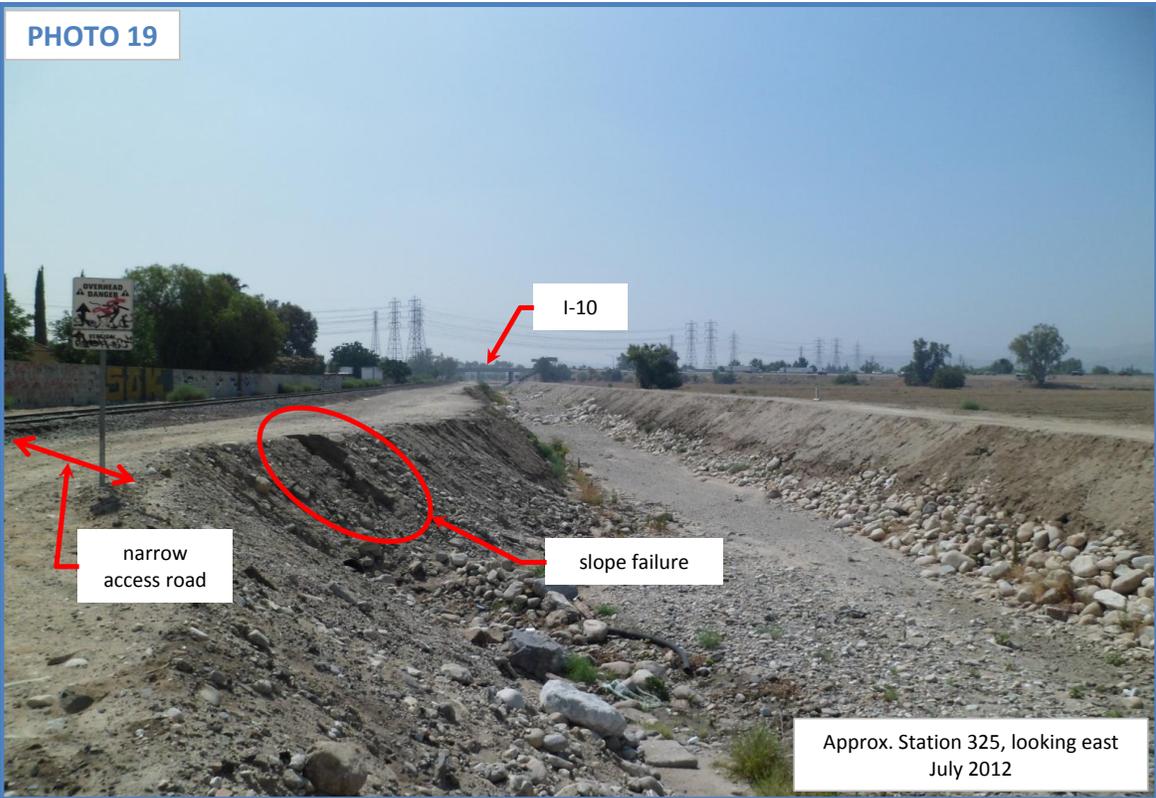
PHOTOS 19 AND 20
 MISSION ZANJA CREEK
 REDLANDS PASSENGER RAIL PROJECT
 COUNTY OF SAN BERNARDINO, CALIFORNIA

326+00	19	Narrow access road, possibly loose soils due to the drainage outlet to Creek. Local surficial failure observed
343+20 to 347+40	23 and 24	I-10 overcrossing with slope face covered with rock and cement grouting
347+40 to 364+00	25 and 26	Unprotected slope face with occasional rocks and boulders. Observed signs of new fills placed on access road and slope face along existing railroad track.
