REDLANDS PASSENGER RAIL PROJECT

Preliminary Geotechnical Evaluation

San Bernardino, San Bernardino County, California

December 2011

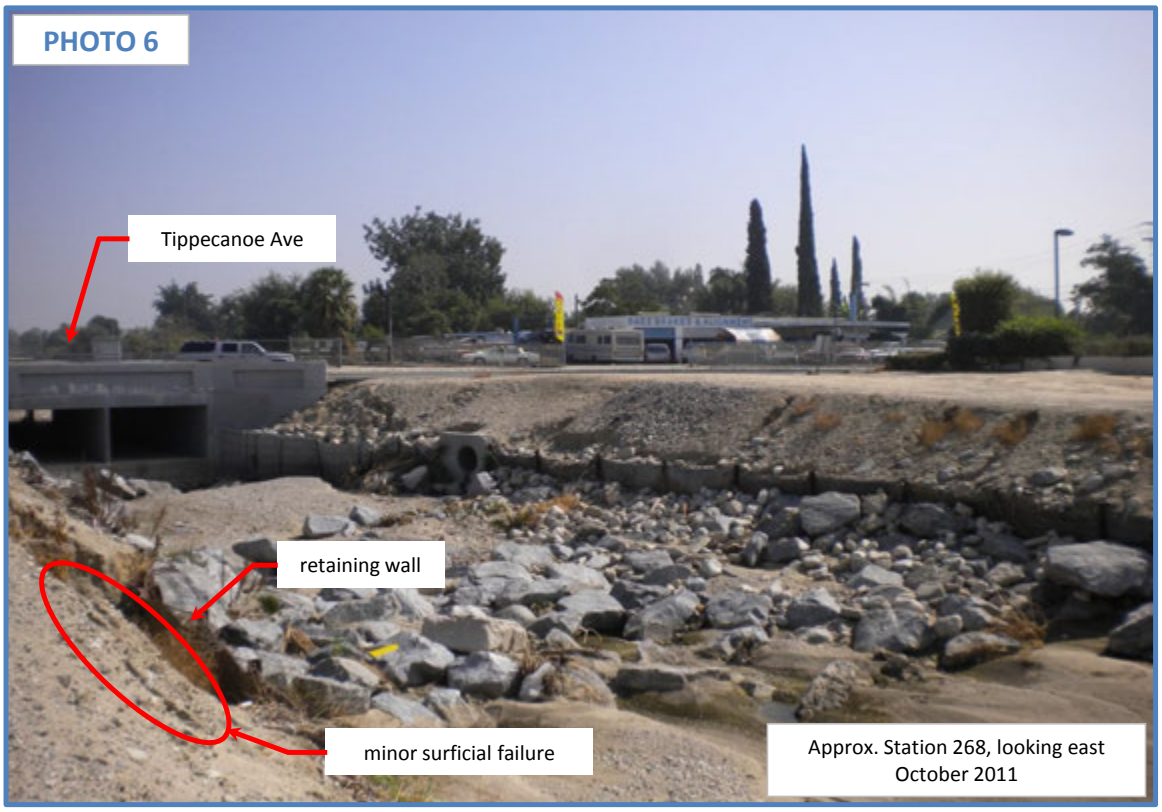
PHOTOS 5 AND 6

Station Nos	Photo Nos.	Existing Conditions
236+00 to 263+00	1 and 2	Slope face covered with trees, bushes and occasionally rocks
263+00 to 263+70	2 and 3	Concrete drop structure, approximately 11 feet in height
263+70 to 267+00	4	Rocks and boulders on slope face
267+00 to 269+00	5 and 6	Approximately 3 to 4 feet high of retaining structure at bottom of slope with rocks and boulders at bottom of Creek. Minor localized surficial/erosion failure or loss of soils behind retaining structure.
269+00 to 269+80	5 and 6	Tippecanoe Avenue Crossing
269+80 to 281+00	7	Unprotected slope face with gravel and cobbles and occasional rocks and boulders
281+00 to 290+40	8 and 9	Several localized surficial/erosion failures observed during site visit in March, 2011. Exposed slope face included garbage mixed with soils. New fills were already placed over localized failure areas during site visit in October 2011.
290+40 to 291+40	10	Retaining structure at bottom of slope with rocks and boulder at bottom of Creek. Encountered refusal on the south side of existing track at shallow depth due to possibly rocks and boulders.

Also the existing slopes between Station Nos approximately 261+00 and 369+00 should be mitigated to minimize surficial/erosion failures. The artificial debris (garbage mixed with soils) observed within areas between Station Nos approximately 281+00 and 290+40 should be completely removed and replaced with compacted fill. An additional field exploration should be performed to verify our preliminary findings and recommendations within the above-named portion of the alignment.

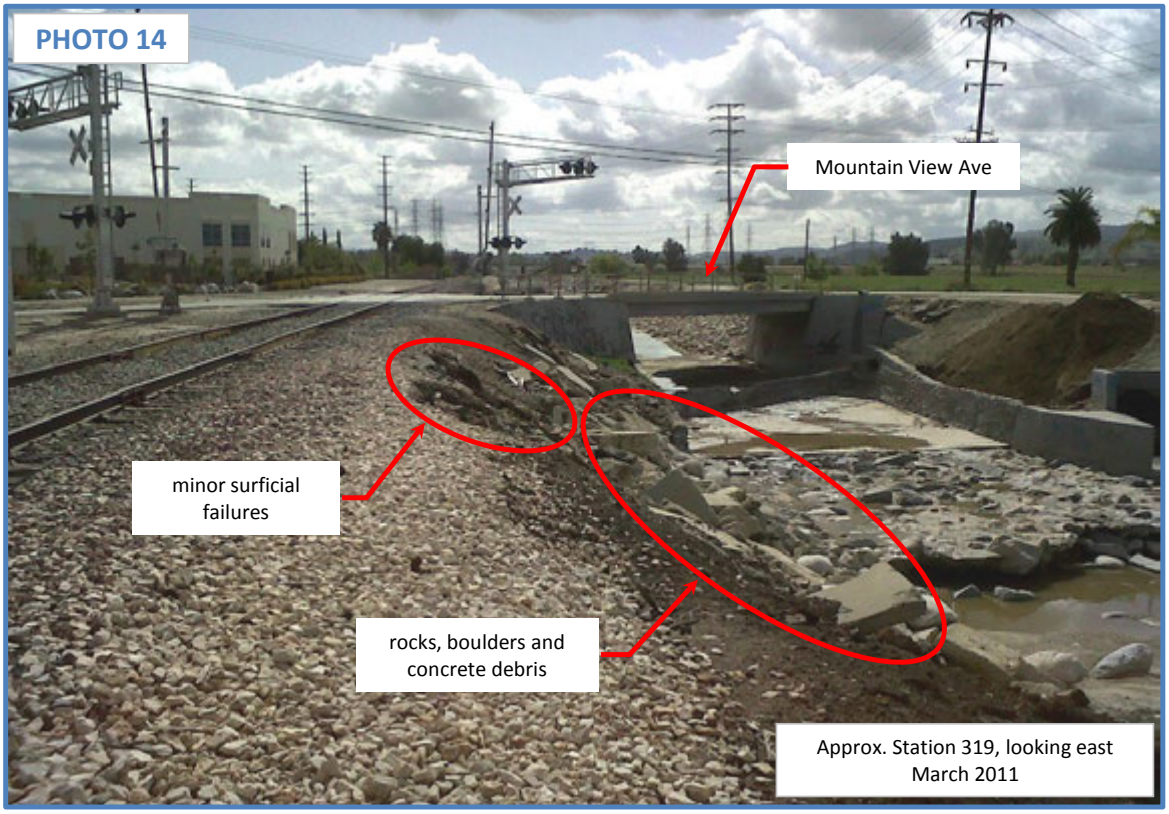
PHOTOS 13 AND 14

291+40 to 292+00	10 and 11	Richardson Street Crossing
292+00 to 320+20	12, 13 and 14	Unprotected slope face with occasional rocks, boulders, asphalt concrete and concrete debris. Several localized surficial/erosion failures were observed during site visits New fills were already placed over localized failure areas during site visit in October 2011. Rocks and boulders were observed at bottom of Creek at several locations.
317+00 to 320+20	15 and 16	Loose concrete debris observed on slope face and exposed steel pipe on slope face. Indication of loose surficial soils
320+20 to 321+00	14	Mountain View Avenue Crossing
321+00 to 323+00	17 and 18	Two concrete panels, possibly part of wing wall for adjacent bridge, were placed on slope face.
323+00 to 343+20	19, 20, 21 and 22	Unprotected slope face with occasional rocks, boulders and concrete debris. Observed signs of new fills placed on access road and slope face along existing railroad track. Several local surficial failure observed

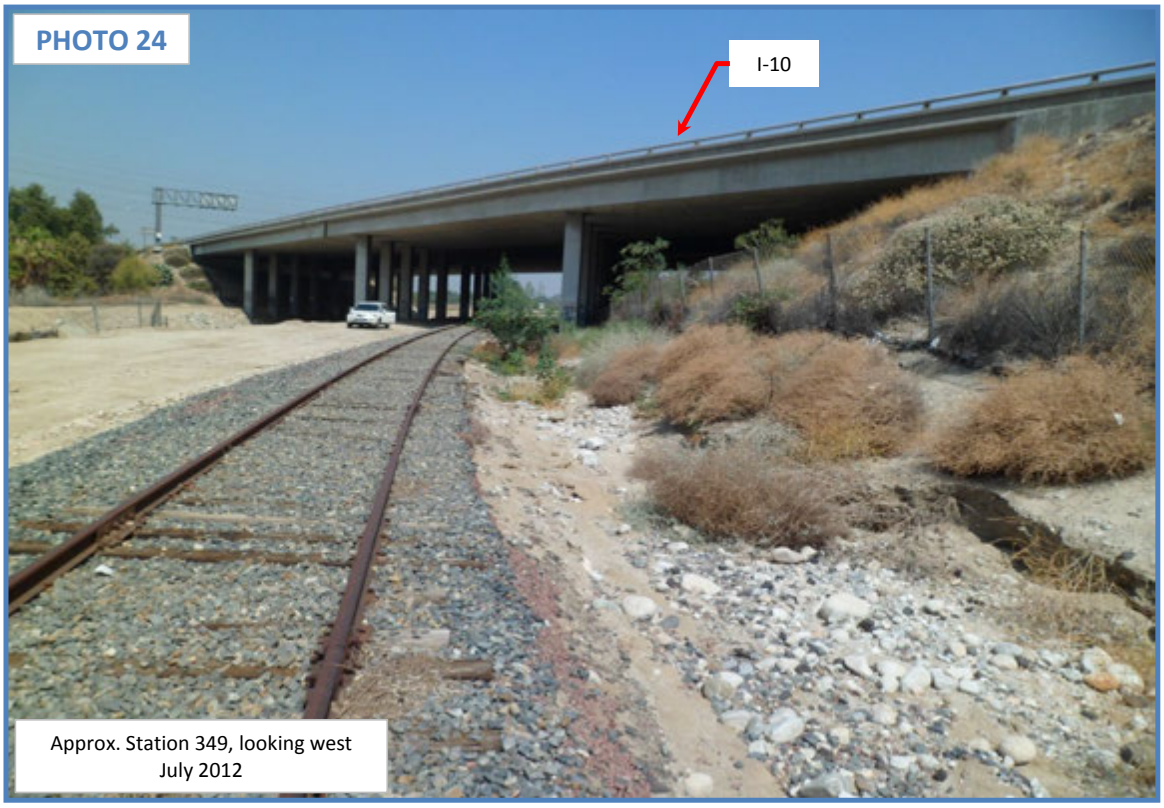
PHOTOS 23 AND 24

326+00	19	Narrow access road, possibly loose soils due to the drainage outlet to Creek. Local surficial failure observed
343+20 to 347+40	23 and 24	I-10 overcrossing with slope face covered with rock and cement grouting
347+40 to 364+00	25 and 26	Unprotected slope face with occasional rocks and boulders. Observed signs of new fills placed on access road and slope face along existing railroad track.
