REDLANDS PASSENGER RAIL PROJECT
Slope Analysis and Photodocumentation
San Bernardino, San Bernardino County, California

July 2012

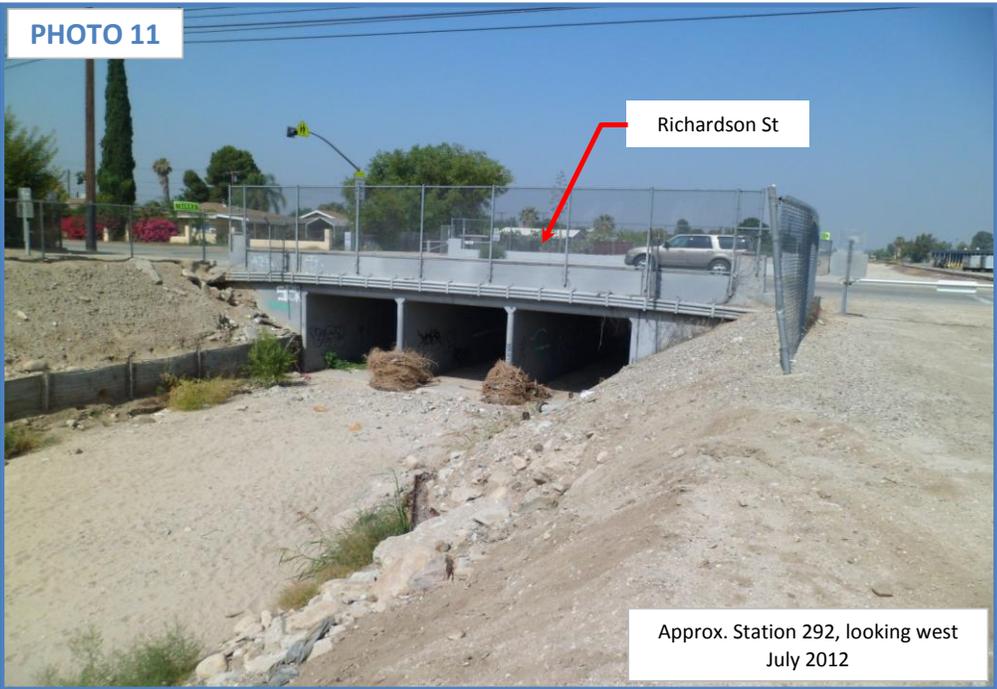
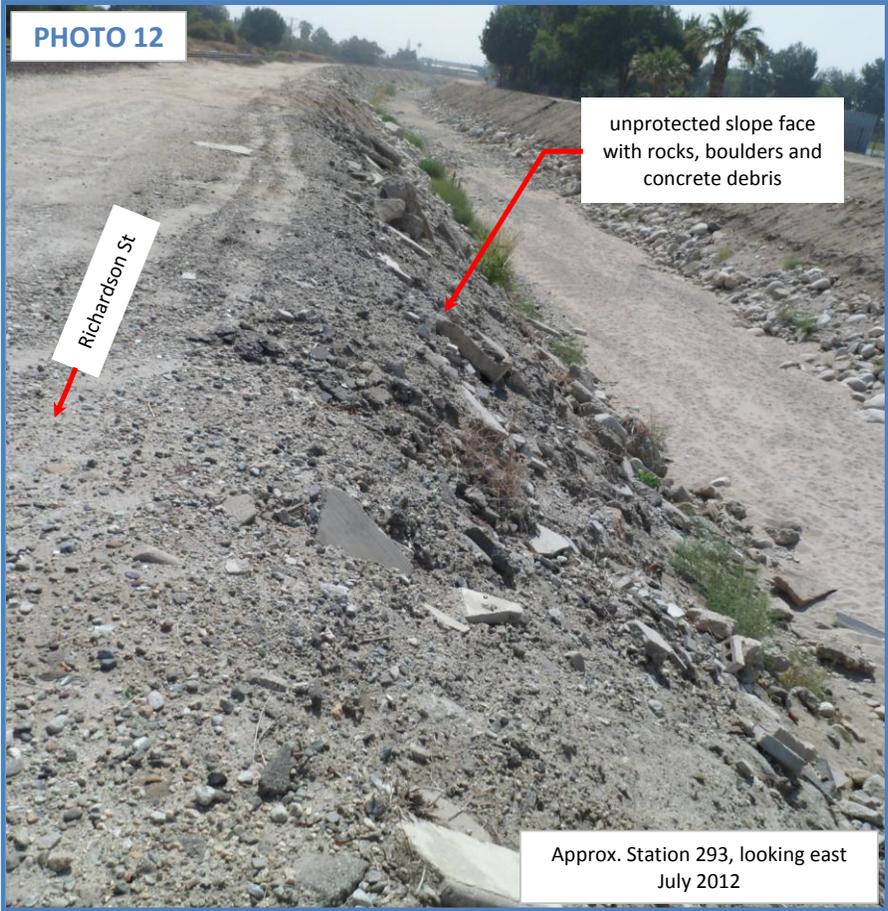
PHOTOS 11 AND 12
MISSION ZANJA CREEK
REDLANDS PASSENGER RAIL PROJECT
COUNTY OF SAN BERNARDINO, CALIFORNIA

291+40 to 292+00	10 and 11	Richardson Street Crossing
292+00 to 320+20	12, 13 and 14	Unprotected slope face with occasional rocks, boulders, asphalt concrete and concrete debris. Several localized surficial/erosion failures were observed during site visits. New fills were already placed over localized failure areas during site visit in October 2011. Rocks and boulders were observed at bottom of Creek at several locations.
317+00 to 320+20	15 and 16	Loose concrete debris observed on slope face and exposed steel pipe on slope face. Indication of loose surficial soils
320+20 to 321+00	14	Mountain View Avenue Crossing
321+00 to 323+00	17 and 18	Two concrete panels, possibly part of wing wall for adjacent bridge, were placed on slope face.
323+00 to 343+20	19, 20, 21 and 22	Unprotected slope face with occasional rocks, boulders and concrete debris. Observed signs of new fills placed on access road and slope face along existing railroad track. Several local surficial failure observed

Also the existing slopes between Station Nos approximately 261+00 and 369+00 should be mitigated to minimize surficial/erosion failures. The artificial debris (garbage mixed with soils) observed within areas between Station Nos approximately 281+00 and 290+40 should be completely removed and replaced with compacted fill. An additional field exploration should be performed to verify our preliminary findings and recommendations within the above-named portion of the alignment.
